Product: **DGN/S1.16.1 DALI Gateway emergency 1f, 16G, MDRC**

Type: **DGN/S 1.16.1**

Current application program: **Switch Dim Emergency 1f DALI/1.0b**
DALI Firmware S0007
ECU Firmware ECU1.0 v14.0

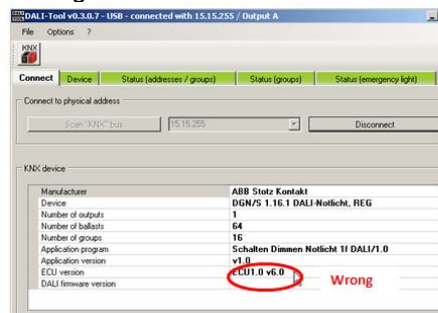
Between March (KW9/2013) and August (KW31/2013) DGN/S1.16.1 was delivered with wrong ECU Firmware. Though this it can happen, that DGN/S 1.16.1 is not visible on KNX. This is also visible that the KNX programming status of DGN/S is no longer displayed in ETS.

Wrong/Fault ECU1.0 v6.0

DGN/S 1.16.1 with wrong Firmware has to be replaced. An update is only possible in factory.

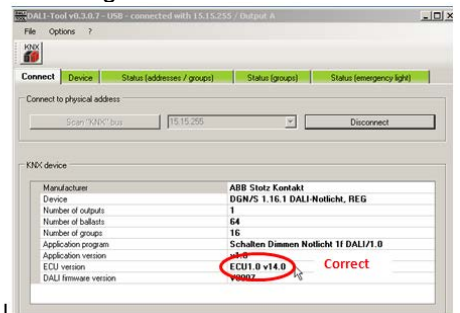
All right ECU1.0 v14.0
