Document class	Release Note
Document ID	2NGA001525
Business Unit	ABB Oy, Distribution Solutions
Page	1/5
Date	14.10.2022

Firmware update release 1.2.0.B7 for 630 series product version 1.2 protection relays

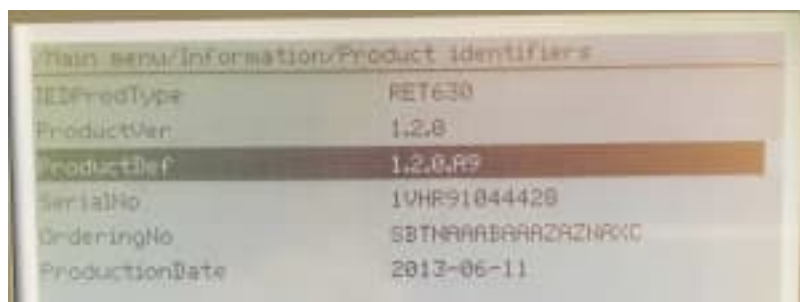
Fig. 2 Current firmware revision of the 630 series protection relay

To identify the current firmware revision of 630 series relays, please note the parameter **ProductDef**, refer to Figure 2.

The 630 series protection relays are to be updated using the software update tool (SUT630Lite). The tool automatically identifies the product order code and installs the correct firmware accordingly.
