# System 800xA

Release Notes

Resolved Issues

System Version 6.0.1

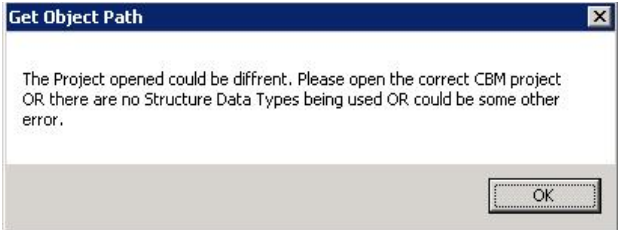
Issue	Correction or Fix
<p>In some cases, after clicking Upload in the SFC Uploader aspect window, the following error message appeared even though the correct project was opened in Control Builder.</p>

<p>800xASFC-OL-5110-001</p>

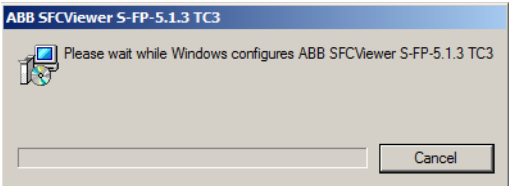
Issue	Correction or Fix
<p>On accessing the SFC Viewer Uploader aspect and Viewer aspect of a library Control Module Type element, in Object Type Structure, the workplace stops responding.</p> <p>800xASFC-OL-5130-007</p>	<p>This problem has been corrected.</p>
<p>SFC upload at the application level might not fetch variables for Structure Data Type of a child SFC, and the object navigation fails.</p> <p>800xASFC-OL-5130-008</p>	<p>This problem has been corrected.</p>
<p>Following software configuration message is displayed for first time, if a graphic display is accessed from any user account other than installed user account:</p>

<p>800xASFC-OL-5130-009</p>	<p>This problem has been corrected.</p>
<p>Communication Variables used in Single Control Module are not listed as part of SFC Viewer Uploader, and they are also not listed in SFC Viewer transition for navigation.</p> <p>800xASFC-OL-5130-010</p>	<p>This problem has been corrected.</p>
