Product: Telephone Gateway, analogue, MDRC

Type: TG/S 3.2

Current firmware version: 0.1.41

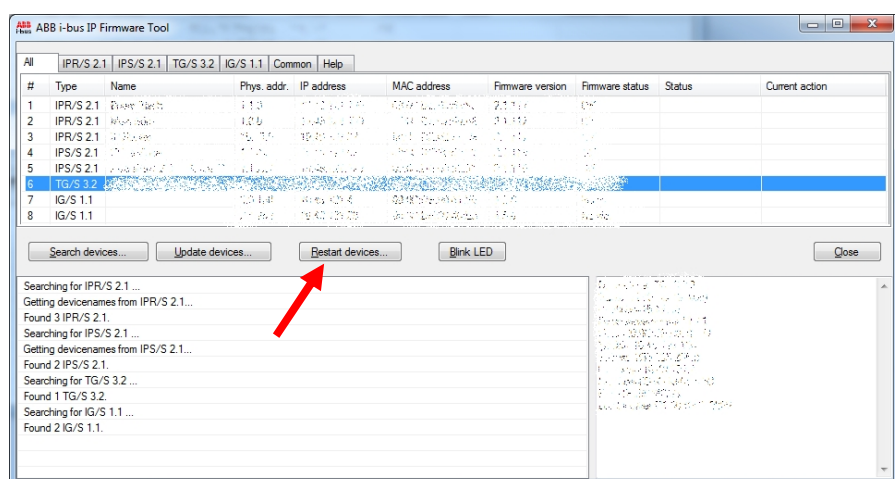
After a firmware update the device must be reset via the update tool (version from 12/2012!). Please click the button "Restart devices..." (example: IP Firmware Tool):
