Solving partial vacuum effects with a vented bushing insert

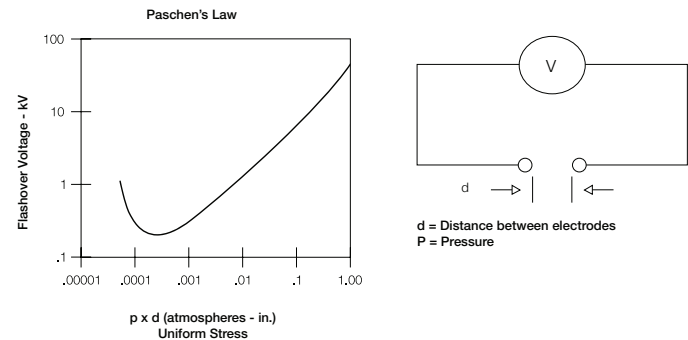
Paschen's Law explains the effect of decreased pressure on the dielectric strength of air, and is illustrated with the following curve:

To see the effect of pressure, let $d = 1$ inch. The horizontal axis then represents pressure only. Note that at 1.0 atmosphere, the flashover voltage for 1 inch is approximately 60kV, and at 0.1 atmosphere, the flashover voltage decreases to approximately 8kV.

This curve illustrates the general relationship and does not represent true data. An accurate curve can be developed for small gaps under controlled pressure, temperature and humidity conditions. The principle applies to the complicated geometry of a connector.

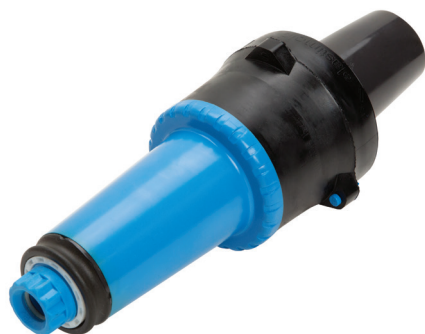
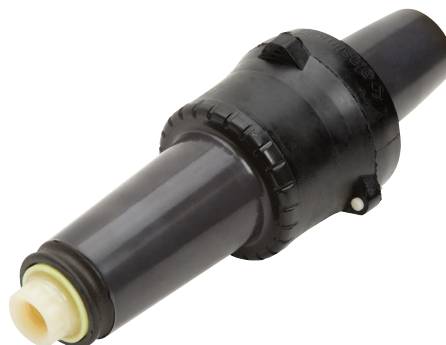
- Vents in the bushing insert ring help equalize the pressure as the connector is removed and prevent (25 and 35kV Classes) flashover conditions
- Elastimold exclusive patented design is a universal solution for any 200A connector application

Vented bushing ring allows external air to enter, which equalizes pressure and prevents conditions that lead to flashover.

- Excellent dielectric mating surface for secure connections
- Rubber-to-rubber sticking eliminated
- Color-enhanced visibility for easy identification and proper installation verification
- Vented ring designed to prevent partial arc flash for enhanced safety
