Document class	Release Note
Document ID	2NGA000845
Business Unit	ABB Oy, Distribution Solutions
Page	1/8
Date	22.12.2020

Firmware update release 2.1.13 for 620 series IEC product version 2.0 FP1 protection relays

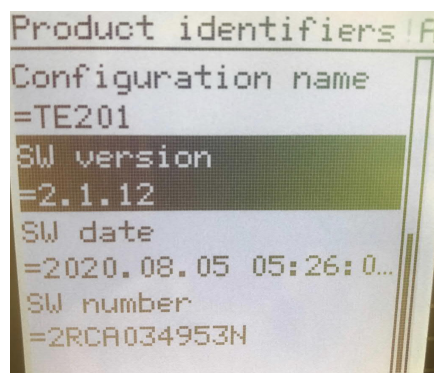
Fig. 2. Product identifiers of the 620 series protection relay

To identify the current firmware (SW) revision of the 620 series protection relay, please refer to Fig. 2.
