System 800xA

Release Notes

New Functions and Known Problems

System Version 6.0.1

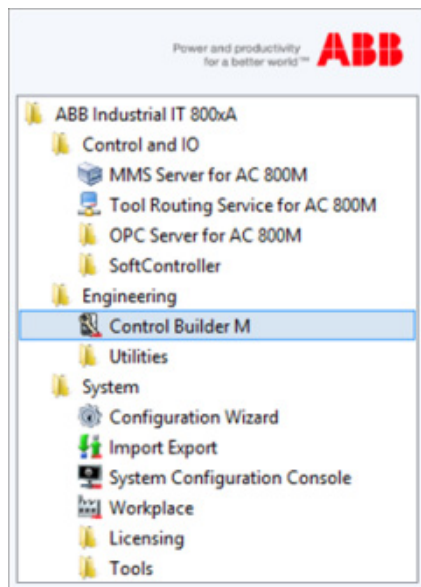
Figure 1. ABB Start Menu

The new ABB Start Menu is used in Windows 8.1 to display a Windows 7 style start menu for the ABB products. The start menu executes only in the desktop environment.

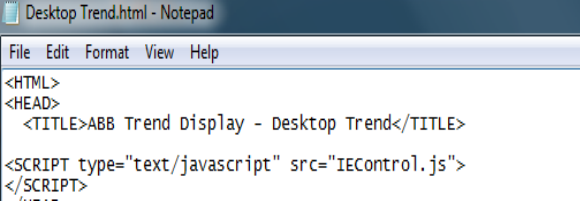
Issue	Workarounds, Clarifications, and Helpful Hints
<p>Desktop Trend files migrated from earlier versions of 800xA will not display properly in version 6.0 due to a compatibility problem with the newer version of Internet Explorer.</p> <p>800xA INM-OL-6000-011</p>	<p>To resolve the issue a compatibility tag needs to be added to the saved Trend file.</p> <ol style="list-style-type: none"> 1. Open the Desktop Trend HTML file with Notepad. The first few lines looks as follows:

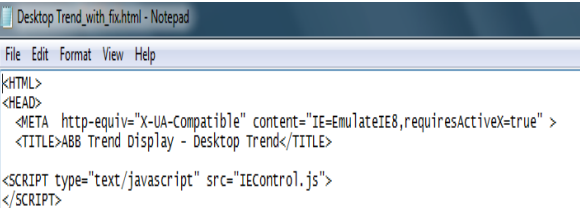
<ol style="list-style-type: none"> 2. Insert the following line of text between the <HEAD> and <TITLE> tags in the HTML file. <pre><META http-equiv="X-UA-Compatible" content="IE=EmulateIE8,requiresActiveX=true"></pre>
