# ABB i-bus® KNX

### Firmware information

Product: KNX Security Panel, SM

Type: **GM/A 8.1**

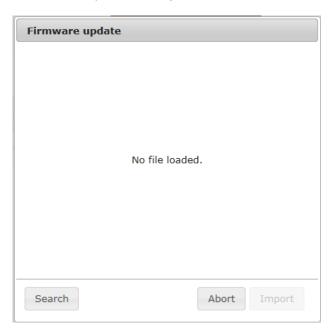
Push Firmware update button

Manufacturer password: Update GMA81

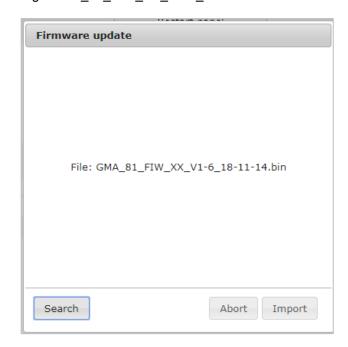
Push Search button and choose update file:

E.g.: GMA\_81\_FIW\_XX\_V1-6\_18-11-14.bin

Push *Import* button.

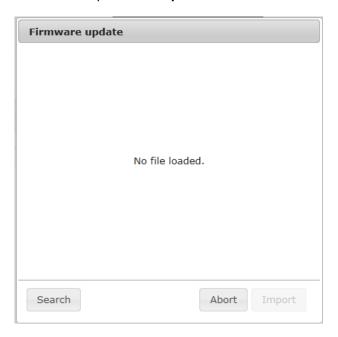
Push Firmware update button

Manufacturer password: Update GMA81

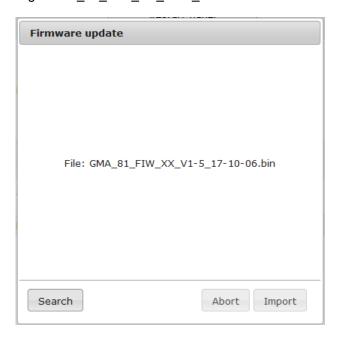
Push Search button and choose update file:

E.g.: GMA\_81\_FIW\_XX\_V1-5\_17-10-06.bin

Push Import button.

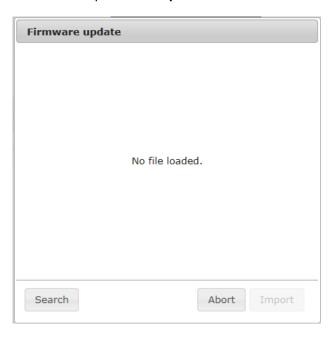
Push Firmware update button

Manufacturer password: Update GMA81

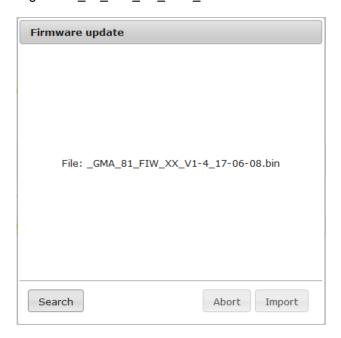
Push Search button and choose update file:

E.g.: GMA\_81\_FIW\_XX\_V1-4\_17-06-08.bin

Push Import button.

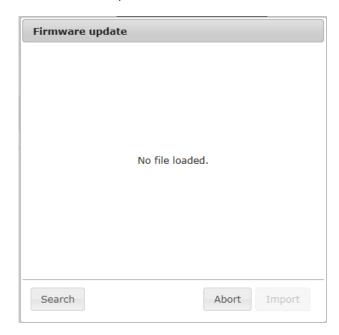
Push Firmware update button

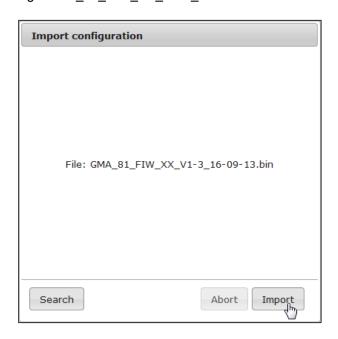
Push Search button and choose update file:

E.g.: GMA\_81\_FIW\_XX\_V1-3\_16-09-13.bin

Push Import button.

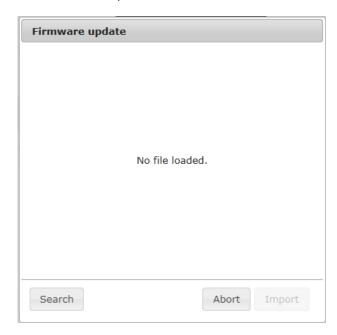
Firmware update

Push Firmware update button

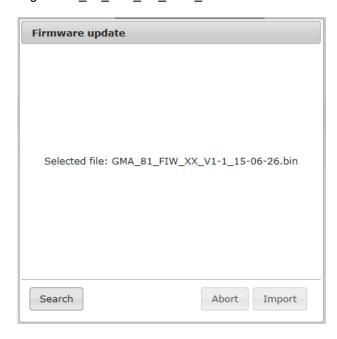
Push Search button and choose update file:

E.g.: GMA\_81\_FIW\_XX\_R1-0\_15-06-26.bin

Push Import button.

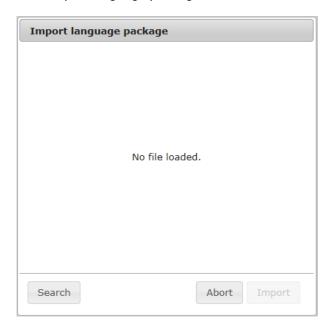
Push Import language package button

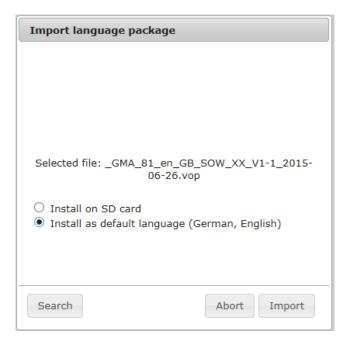
Push Search button and choose language package:

E.g.: GMA\_81\_en\_GB\_SOW\_XX\_V1-1\_2015-06-26.vop

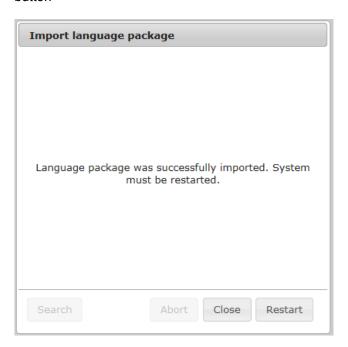
Select Install as default language (German, English) and push Import button

Close dialog via *Close* button (no restart). Repeat steps from step 5 for German language package. After import finished again, push *restart* button, to finish language package installation.
