Document class Release Note
Document ID 1MRS758931
Business Unit ABB Oy, Distribution Solutions
Page 1/4
Date 19.1.2018

Firmware update release 4.0.6 for 615 series IEC product version XE protection relays

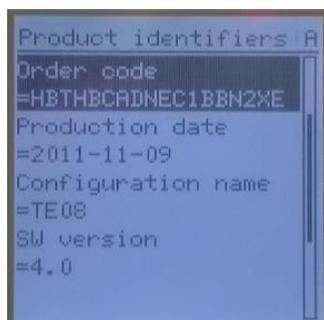
Fig. 2 Current firmware revision of the 615 series protection relay

To identify the current firmware (SW) revision of the 615 series protection relay, please refer to Fig. 2.
