Document class	Release Note
Document ID	2NGA000480
Business Unit	ABB Oy, Distribution Solutions
Page	1/9
Date	21.08.2020

Firmware update release 2.1.12 for 620 series product version 2.0 FP1 (G) protection relays

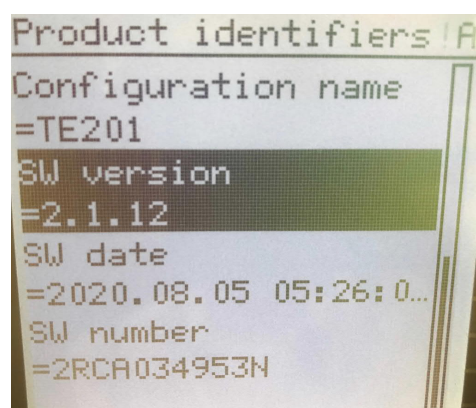
Fig. 2. The firmware revision of the 620 series protection relay

To identify the current firmware (SW) revision of the 620 series protection relay, please refer to Fig. 2.
