ABB industrial drives

ACS580MV primary control program Troubleshooting manual

2UBB005092 Rev Q EN EFFECTIVE: 2023-12-30

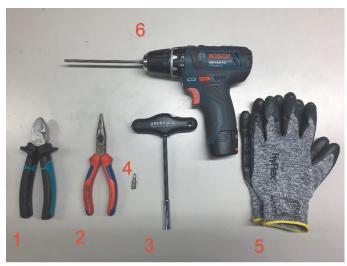
Necessary tools:

Index	ТооГТуре
1	Cable cutter
2	Sharp-nose plier
3	Combination screwdriver
4	125 torx bit
5	Protective gloves
6	Auto screwdriver

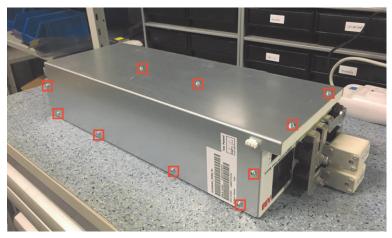
Step 1: remove red marked screws and open the PEBB.

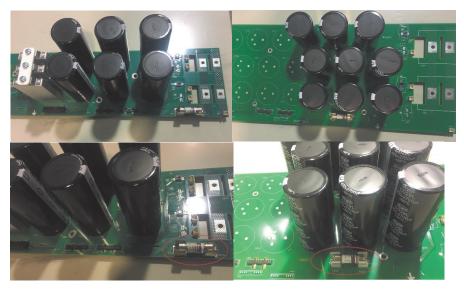
Please refer section *Open the Power Module* to open the PEBB first. And you can find fuse link following photos.

Left photos are PEBB0 frame, right photos are PEBB1 frames.

Use multimeter plus and minus probes test two holders of fuse, the value should lower than 1 ohm.

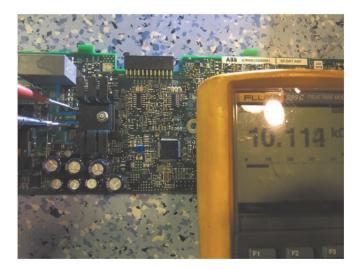
MOSFET failure happens when the resistance is almost 0ohm.
