Product: **Shutter Actuators JA/S**

Type: **JA/S 2.230.1, JA/S 4.230.1, JA/S 8.230.1,
JA/S 4.230.1M, JA/S 8.230.1M, JA/S 4.24.1, RA/S 4.230.1**

General Information	to:	Shutter, xf/2.5 Shutter, xf M/2.5 Shutter, 4f 24V/2.5
	from:	08/2008

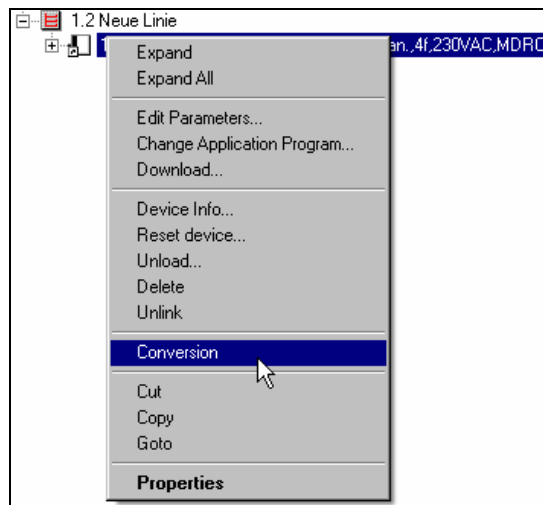
- Click with right mouse key on the device (JA/SX.XXX.X) in ETS 3
>> The sub menu with the menu option "Conversion" is faded in:

- Click on “Conversion”.
>> The dialog window for starting the conversion is faded in.
- Click on „Adopt previous program version“ and follow the instructions.

Version 2.3 offers the possibility to take over parameters and group addresses from older versions (from version 2.0) of the application (only with ETS 3). Therefore the effort on parameterisation can be minimized. See succeeding steps how to start conversion:
