Product: **Room Controller, 8-fold, SM**

Type: **RC/A 8.1**

Current application program: **Room Controller modular 8f/2.1**

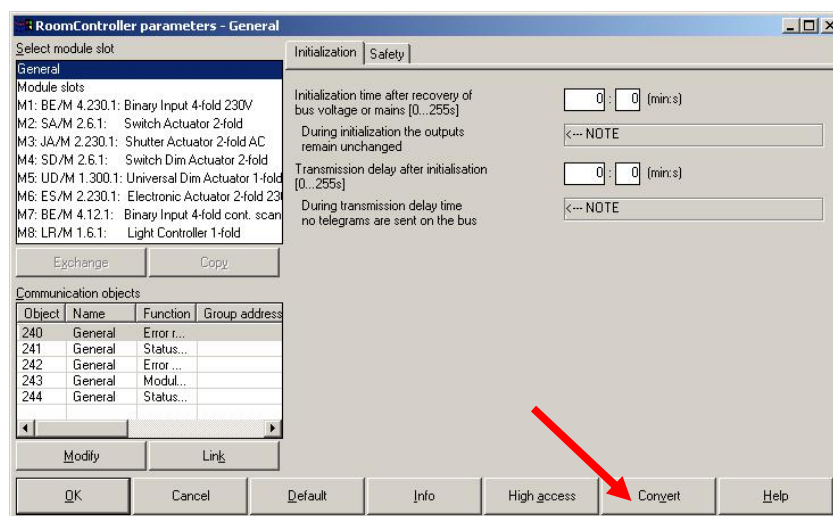
- Import the latest application program “Room-Controller modular, 8f/1.3” into the ETS3
- Insert a new device into the project
- Select the new device and call “Edit Parameters”

→ press the button “Convert”

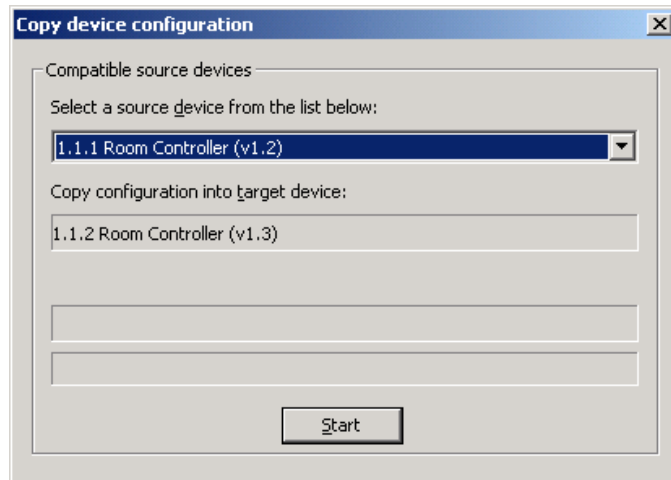
→ click on „yes“

- Here all existing Room Controller devices with an older software version are listed. Select the device for the conversion.
- After the conversion („Start“) the new Room controller device contains all the information of the selected device. The old device can now be removed from the project.
